Surlingham Parish Council

Summary of the findings of the Flood Resilience Committee

Dated 19 May 2021

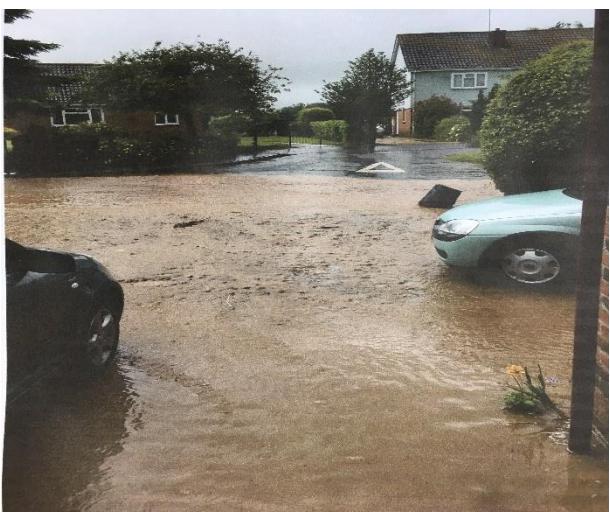
Mill Road (No 1 on the map) is the highest point in the village and runs south to north towards the junction with The Green. Flooding here results from run-off from fields on the west side. When that surface water reaches Mill Road, it runs north, i.e., down-hill, towards The Green. Due to the camber, water flows across the road and into driveways and garages of several properties on the east side that are set below the level of the road.

Drains are a contributing factor being blocked, inadequate or positioned too far into the road to capture the water.

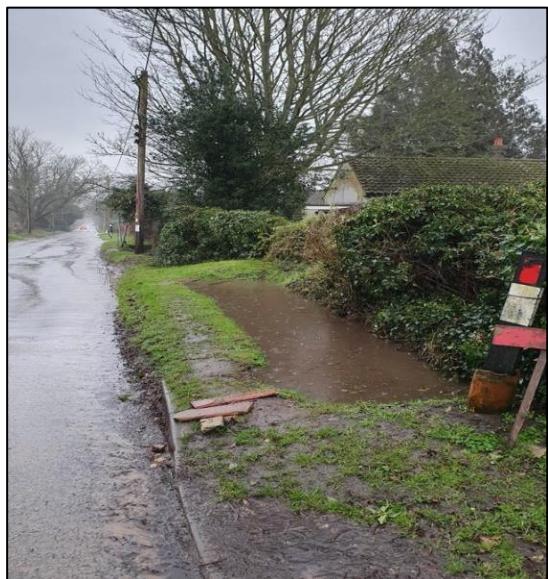
Further down on The Green on the South side ditches have not been dredged for some time and ditches half full of silt have plants growing in them further reducing efficiency. Blocked, inadequate, or damaged letterbox gullies add to the problem. During heavy rainfall, rather than surface water running off the road and into the roadside gullies, in places the opposite occurs,

indicating that either the gully is blocked or simply unable to handle any more water.

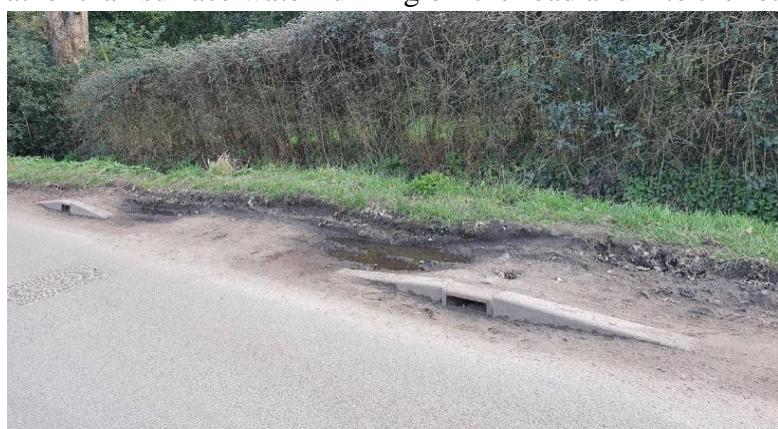
On some occasions the parking of vehicles on The Green results in heavy goods vehicles and the bus, as well as ordinary cars, having to mount the opposite verge in order to pass. At one location this has resulted in the destruction of the letterbox drain that takes water from the road into the ditch. This has been reported to Norfolk County Council.

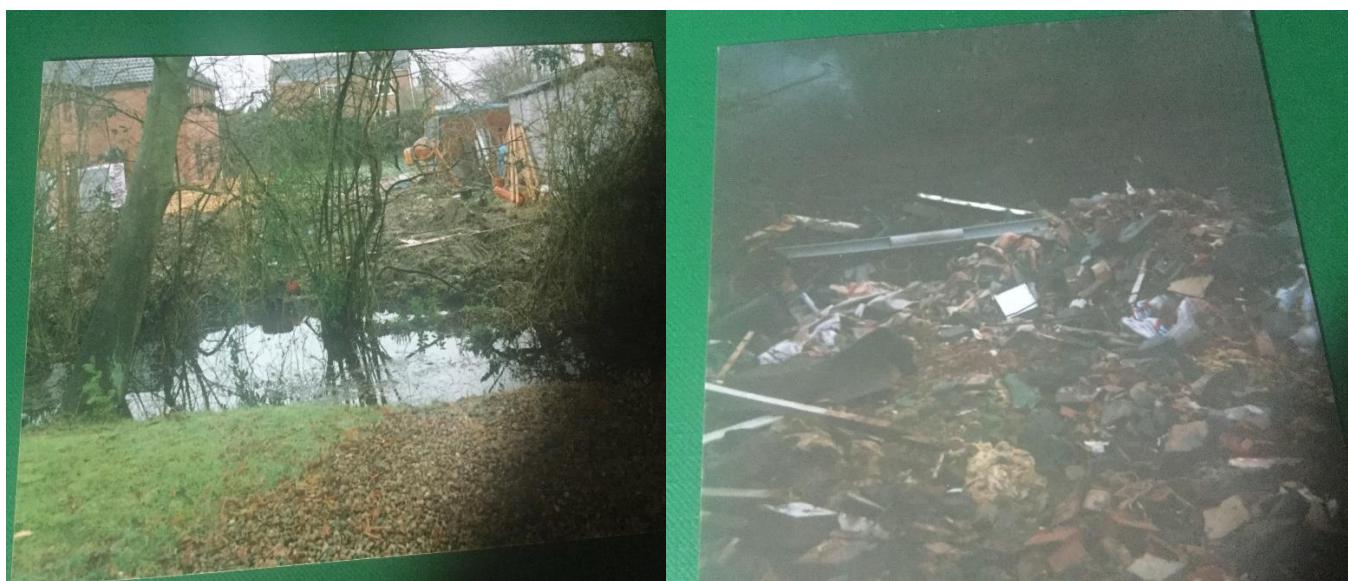
Cut Loke (No 5 on map) Before the traffic island was built at the junction of The Covey, water flowing down The Green would flow across The Covey into the water meadows opposite. Now the water flows into Cut Loke and along The Street because the drainage pipes and ditches are constantly blocked. Parishioners have cleared these blockages so the water can be diverted into the water meadow. See photograph on the right).

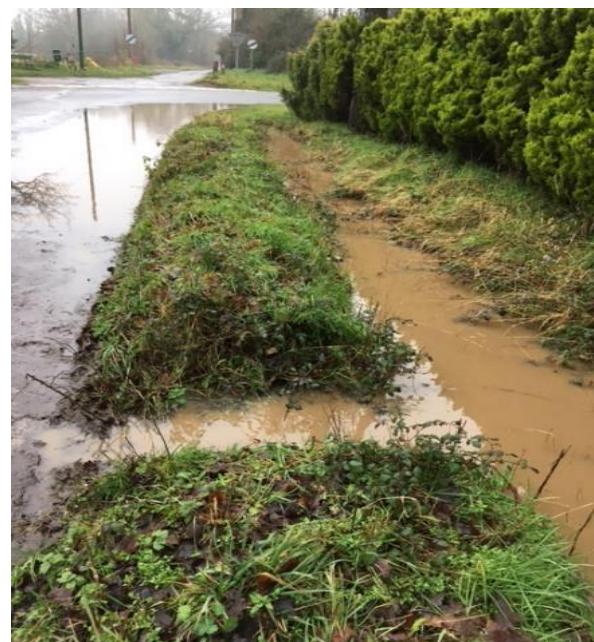
The Street (No 6 on map) incidents on The Street are of two different types, surface water/poor drainage and tidal flooding. As with The Green, the main cause of surface water flooding affecting properties is that roadside ditches are blocked with debris and vegetation and need clearing more frequently. Storm drains are not working efficiently. The Street is a narrow road and when vehicles park on the road they do so on the verges, over time forcing the soil into the storm drains stopping water flowing away. An additional issue is that the pumping station at Berelicks Loke frequently fails.

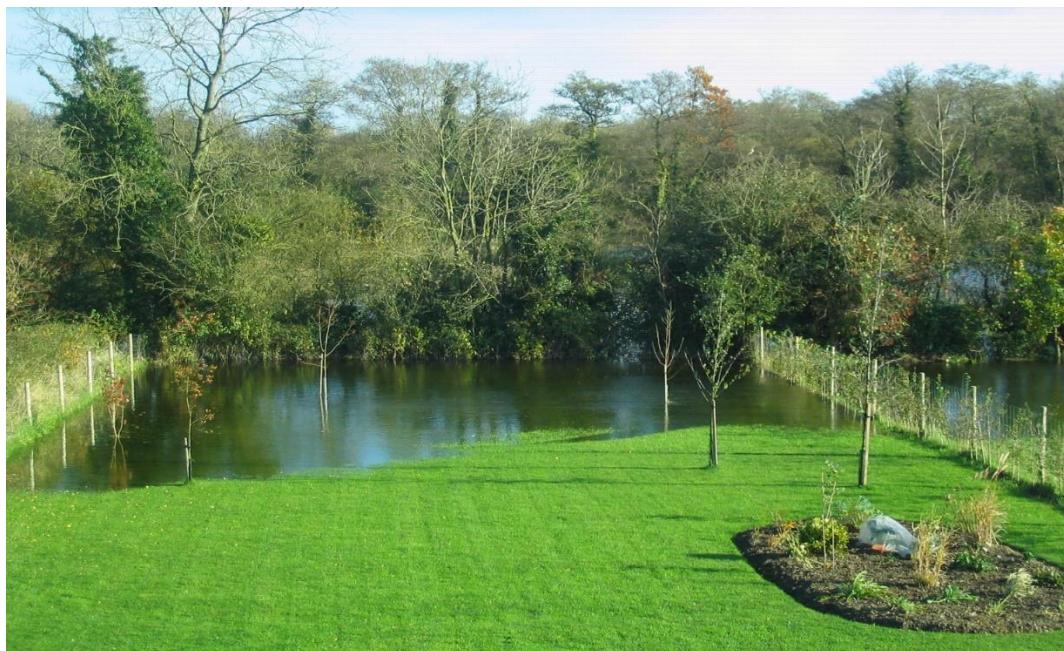
The properties on the east side of The Street back onto the marshes separated by dykes and drainage ditches which are choked with silt and vegetation. These areas are subject to regular tidal flooding. Residents are keen to understand what steps could be considered such as dredging overgrown channels between these areas, the river and Bargate Broad.

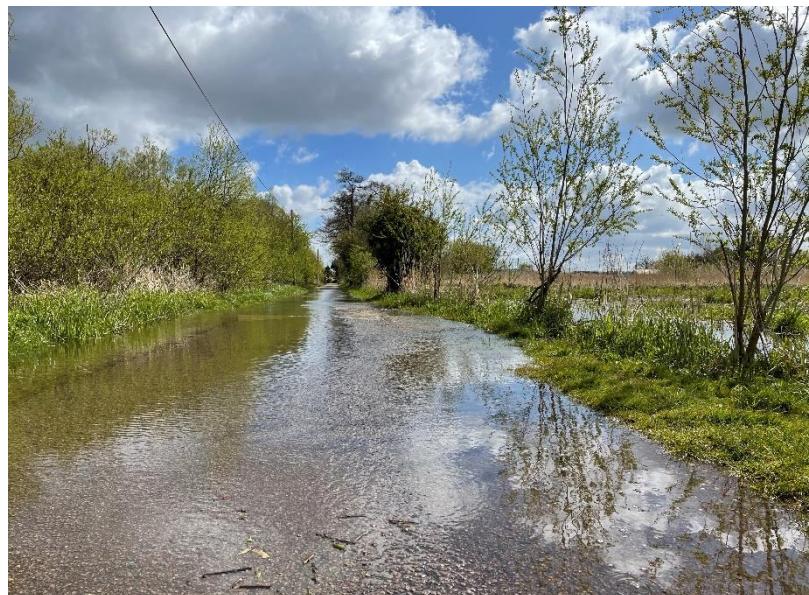
RSPB/Norfolk Wildlife Trust have maintained the South dyke on the Carnser (to the right in this photograph) but that is not enough to stop the water flowing over the road. Because no drainage is maintained to the north the water flow is now so fast it washes out all the maintenance done to the surface of the Carnser, plus the floods are now spreading over a larger area affecting more and more residents as the water has nowhere to go.
