Surlingham Parish Council

Summary of the findings of the Flood Resilience Committee

Dated 19 May 2021

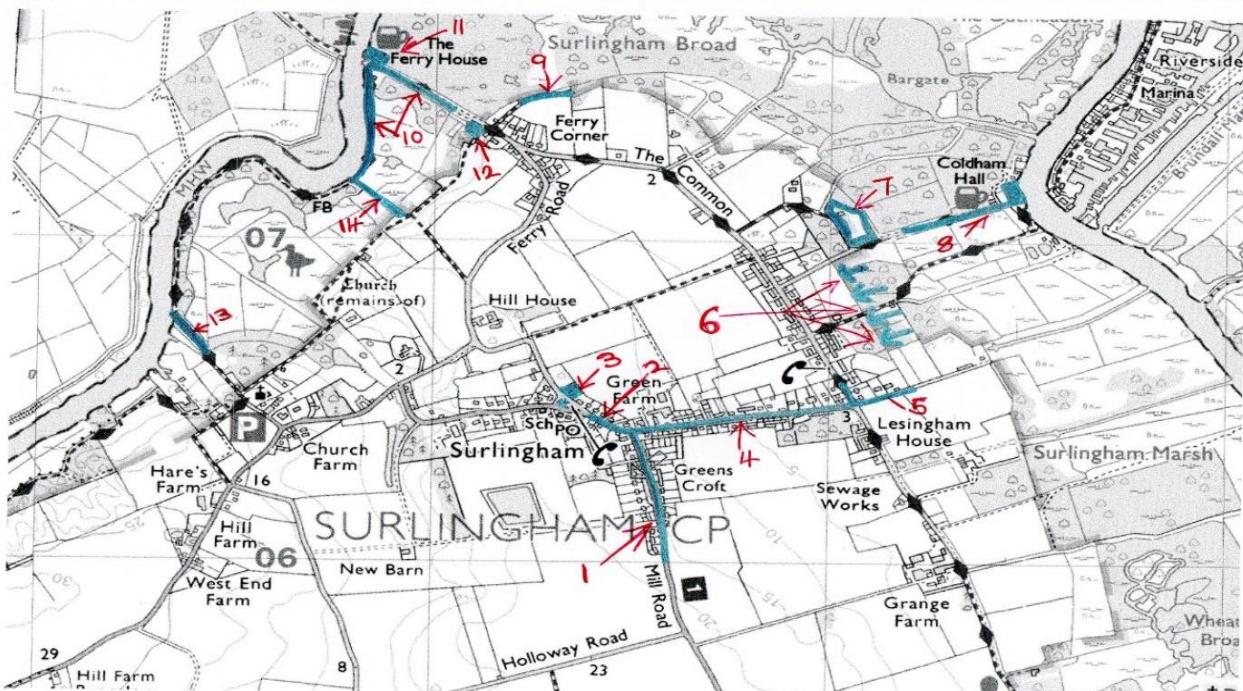
Mill Road (No 1 on the map) is the highest point in the village and runs south to north towards the junction with The Green. Flooding here results from run-off from fields on the west side. When that surface water reaches Mill Road, it runs north, i.e., down-hill, towards The Green. Due to the camber, water flows across the road and into driveways and garages of several properties on the east side that are set below the level of the road.

School Road and Pond Lane (Nos 2 & 3 on map) Here flooding of gardens and driveways is due to poor drainage. When the pond overflows it floods Pond Lane. Traffic is stopped from using the lane to protect one property where the surge from passing vehicles soaks the wall above the level of the damp proof course.

The Green (No 4 on map) Flooding on the north side affects those properties that are below road level. As run-off flows from Mill Road down The Green during spells of heavy rainfall, the ditch at the top of The Green on the south side quickly fills and then overflows onto the road. The underlying cause of the problem is believed to be the accumulation of silt & mud deposited over time in the first section of ditch. These deposits then block the through pipe to the second ditch leaving it half empty. In addition, there is a grid over the front of the interconnecting pipe, and it has been suggested that this makes it easier for debris to build up, such as leaves & litter.

The Street (No 6 on map) incidents on The Street are of two different types, surface water/poor drainage and tidal flooding. As with The Green, the main cause of surface water flooding affecting properties is that roadside ditches are blocked with debris and vegetation and need clearing more frequently. Storm drains are not working efficiently. The Street is a narrow road and when vehicles park on the road they do so on the verges, over time forcing the soil into the storm drains stopping water flowing away. An additional issue is that the pumping station at Berelicks Loke frequently fails.
